# Attachment B to April 14, 2021 Notice of Violation

### COMPLIANCE EVALUATION INSPECTION REPORT

Sonoma County Water Agency  
Russian River County Sanitation District  
(Guerneville Collection System)  
800 Aviation Boulevard  
Santa Rosa, CA 95403

12-06-2019  
Entry: 0820  
Exit: 1445

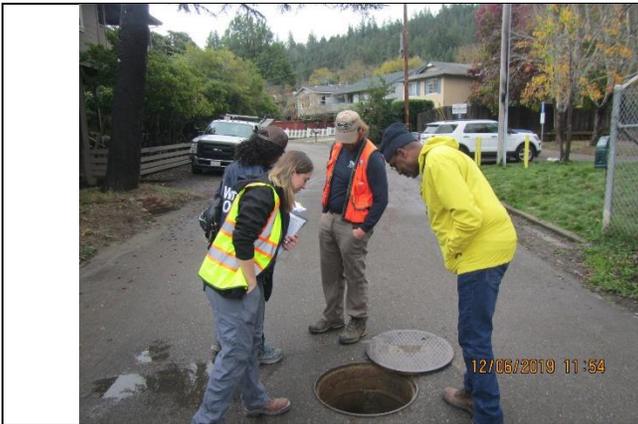
**Photo 3:** MH 6-1 located on Orchard Avenue.

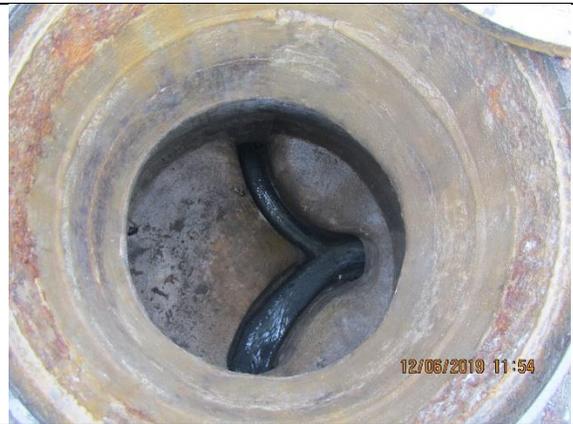
**Photo 4:** Inside of MH 6-1 located on Orchard Avenue. Observed some corrosion. Manhole bench and barrel appeared clean at time of inspection.

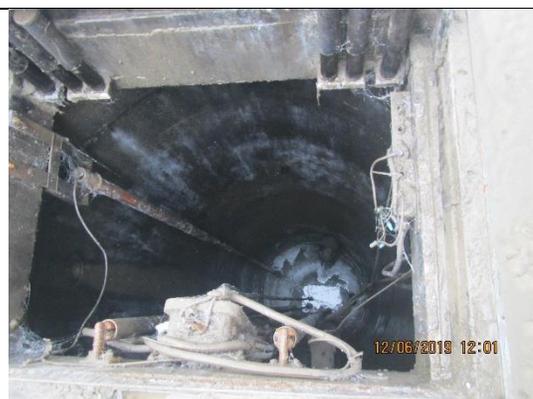
**Photo 6:** Wet well at Vacation Beach Lift Station. Observed evidence of corrosion, exposed wiring, and pump rail wear.

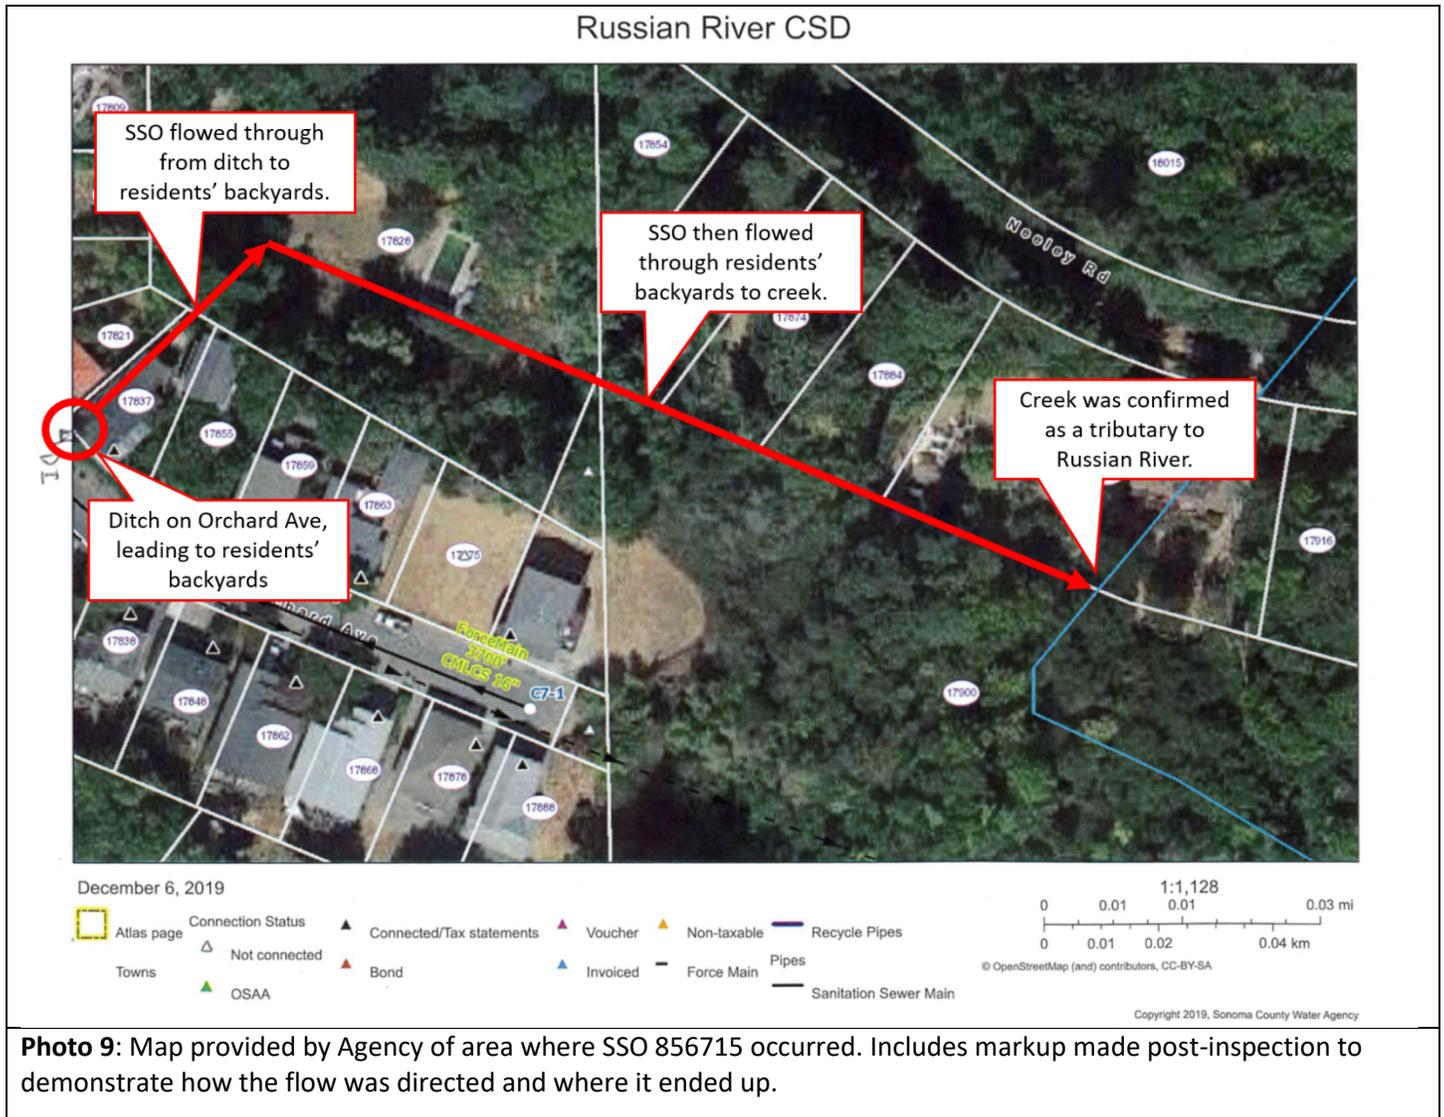
Mr. Royall next provided me with a map of the area (**Photo 9**) to explain how they directed the flow during CIWQS Event ID SSO 856715 which occurred on February 26, 2019. Mr. Royall showed how the flow was directed to the backyards. I observed a downward slope that led to a creek. I asked Mr. Royall if the SSO would have flowed from the backyards down to the creek, which he confirmed. I next asked if the creek was a tributary to the river, which he also confirmed. Given this information, I commented that if the SSO was directed by sandbags into the backyards and the slope in the backyards allowed for the flow to enter the creek, which is tributary to the river, then the entire volume of the spill ultimately ended up in the river. Mr. Royall agreed that this was accurate and what would have occurred. I informed him this meant the information entered into CIWQS was incorrect and would need to be revised to show the entire flow volume entering a body of water. As such, this spill would also need to be revised from a Category 2 to a Category 1.

Agency staff indicated that this coming winter they will avoid any intentional directing of SSOs to the drainage pipe. Instead they plan to sandbag in such a way that the spill will be directed down Vacation Beach Road directly to the river instead of into the drainage pipe that leads into the backyards of residents.

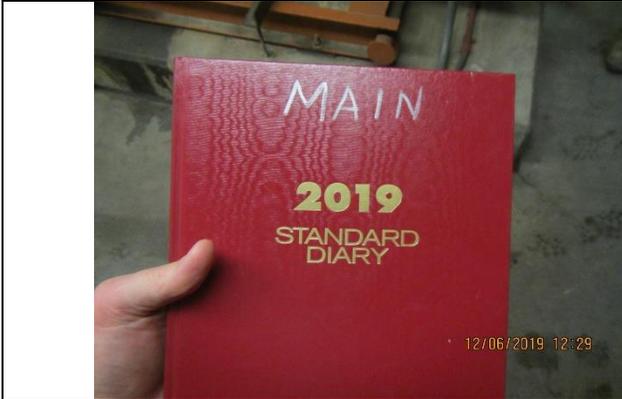
Orchard Avenue manhole and aeration basin overflows at the WWTF. Mr. McIntee next asked to review the maintenance logbook which was provided (**Photo 10**). Mr. McIntee observed that the logbook appeared to be missing entries (**Photo 11**) and inquired about this. We were told that collections operators mainly utilize digital records on computerized maintenance management software (CMMS) versus logging maintenance entries in logbooks.

**Photo 10:** Maintenance log book for Main Lift Station. Many pages missing information (recorded in CMMS).

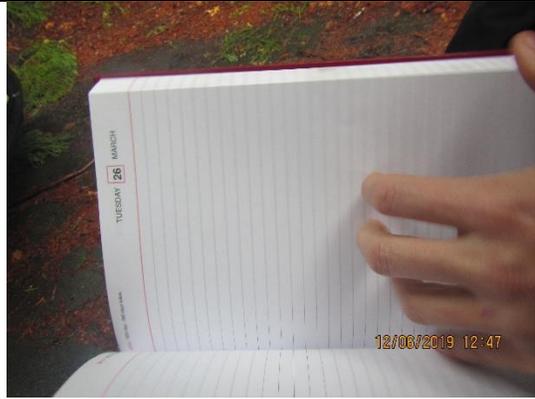
**Photo 11:** Example of page with no written entry.

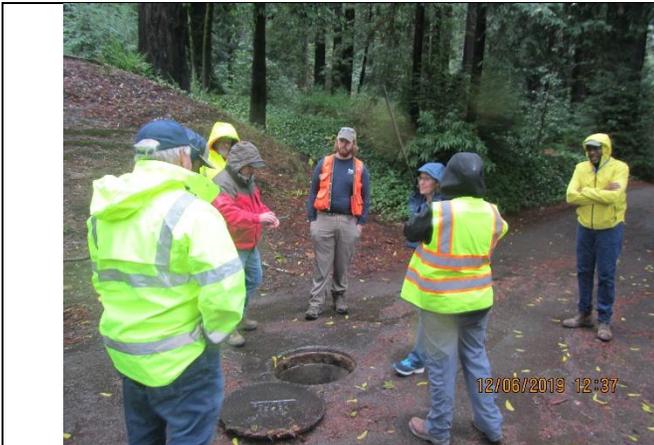
**Photo 12:** MH 17-23 on Riverside Road. Location of historical SSOs.

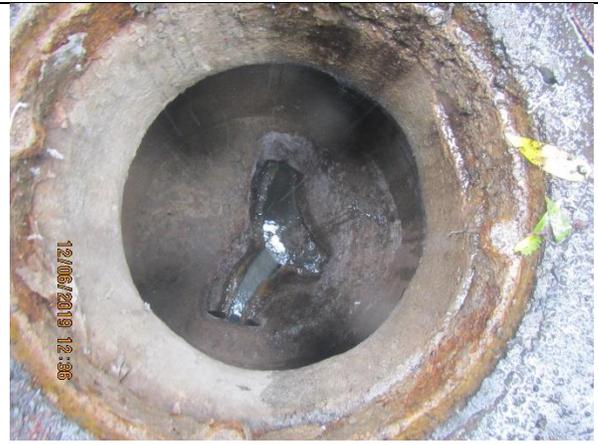
We next walked to MH 17-23 located on Riverside Road behind the lift station (**Photo 12**) where historic SSOs have occurred. MH 17-23 has two pipes which flow into it and one pipe that flows out (**Photo 13**). We observed clear flows in the channel and some corrosion on top of the manhole barrel and on the base ring.

**Photo 13:** MH 17-23 on Riverside Road. Observed some corrosion on top of manhole barrel and on the base ring. Clear flows in channel at time of inspection.

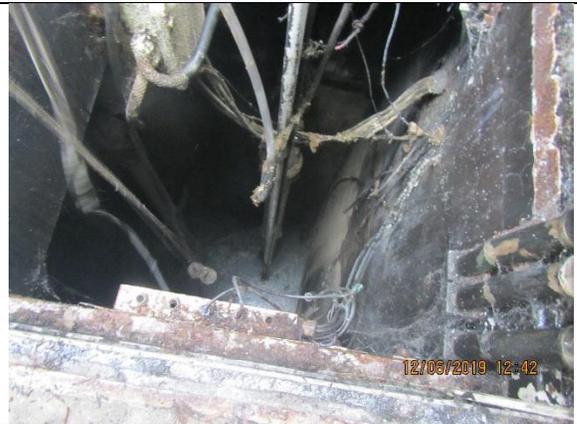
**Photo 15:** Wet well at Main Lift Station. Observed evidence of corrosion, exposed wiring, and pump rail wear.

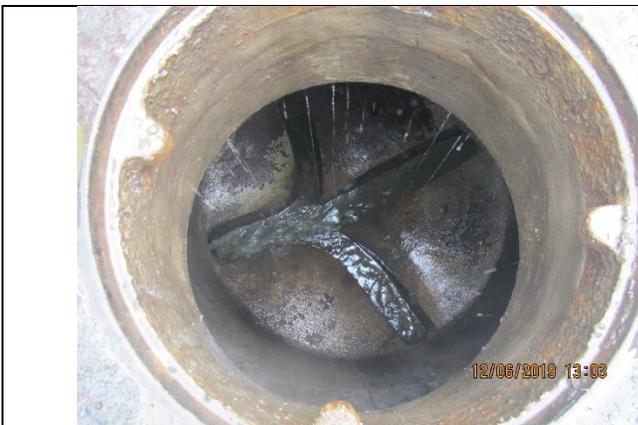
**Photo 16:** Manhole located on Mill Street. Dark, silty material observed on the bench.

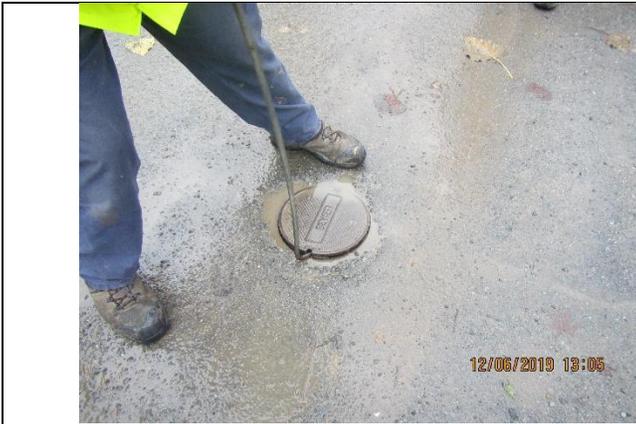
Mr. Royall next walked us over to one of their isolation valves (**Photos 17 and 18**) located adjacent to several residential homes on Mill Court including their sewer lateral connections. Agency staff stated the valve has historically been closed to isolate the homes, which were once at ground level to prevent flood waters from getting into the collection system through fixtures in the home. Many of the homes in this area have been raised (**Photo 19**). Agency staff stated that in the future when all the of the homes have been raised, they may no longer need to close this valve during storms.

**Photo 18:** Isolation valve on Mill Court. Used to prevent excess floodwaters from entering private lateral sewer connections.

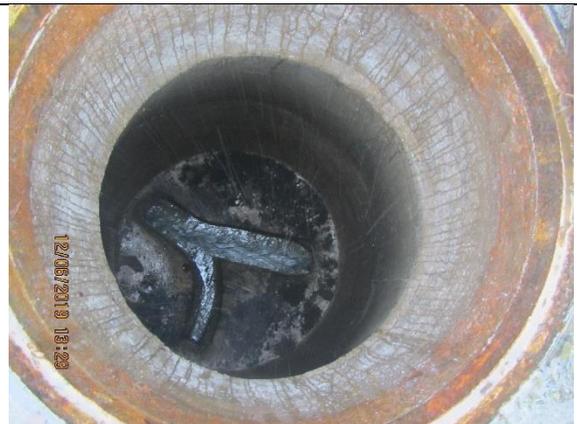
**Photo 18:** Inside of MH 51-7 located at Guerneville Elementary School. Minimal evidence of surcharging was observed inside manhole barrel. Dark, silty material observed on the bench.

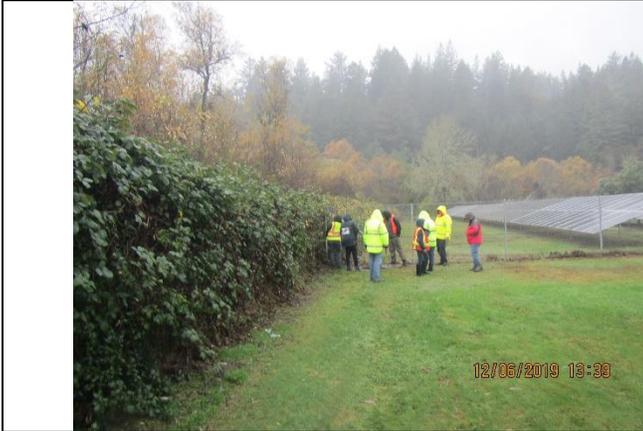
**Photo 19:** Location of MH 51-8 in far corner of field at Guerneville Elementary School. Identified as vulnerable area of potential surcharging.

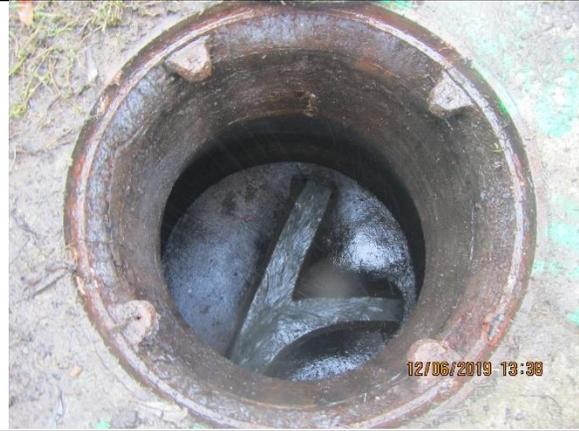
When Mr. Winton returned, we proceeded to open manhole 51-8 (**Photo 19**). We observed that this manhole had a shallower depth than other manholes observed in the system. We observed a clear channel and clear barrel. We also observed dark staining on the manhole barrel approximately halfway to three-quarters of the way up, which indicates

flows consistently reach high levels within the manhole, evidence of surcharging. As with the upstream manhole, a dark silty material was observed on the bench (**Photo 20**).

**Photo 20:** Inside of MH 51-8 located at Guerneville Elementary School. Evidence of surcharging was observed inside manhole barrel. Dark, silty material observed on the bench.

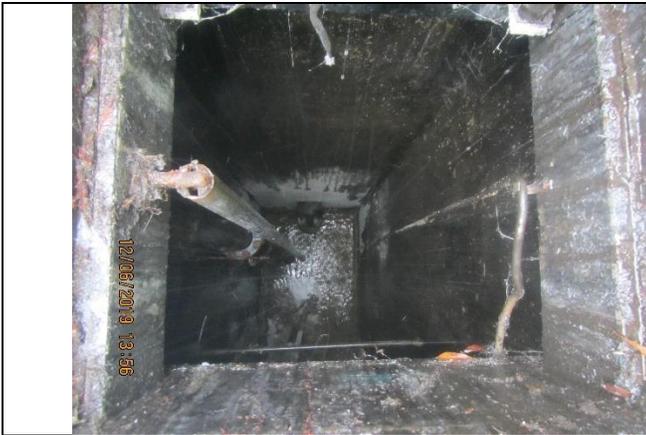
Next, we met at the Rio Nido Lift Station at approximately 1400. This lift station appeared to be in similar condition to the two lift stations observed earlier in the inspection (**Photos 21 and 22**). Mr. Fischer requested an alarm test be performed. Mr. Barker conducted a simulated high float test on pump number three (**Photo 23**) and we observed the auto-dialer working as expected. We also visually observed an alarm light turn on during the test which was mounted on the lift station building. We observed that the main sewage flow line near the bottom of the wet well showed no evidence of surcharging or solids. A light FOG blanket was observed high on the surface of the wet well.

**Photo 21:** High flow test at Rio Nido Lift Station. Observed evidence of corrosion and surcharging. FOG mat present.

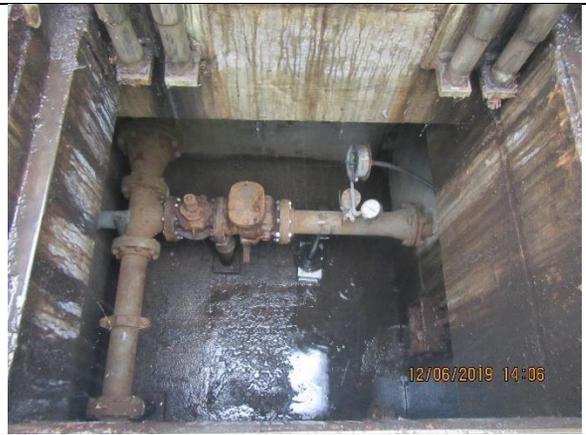
Mr. Fischer next asked about the condition of the lift station isolation control valves located below grade in large vaults located adjacent to the station’s wet well access doors (**Photo 24**). We were told one isolation valve along with an old flow meter were currently out of service. We learned after going out of service approximately one to two months ago,

**Photo 24:** Valve No. 1 currently out of service at Rio Nido Lift Station.

RRCSD is currently waiting on new valve parts and plans during the next window of dry weather to replace all three valves at the same time. We learned these valves were installed in 1978, so RRCSD staff said it is only a matter of time before the other two valves fail and it is more efficient to replace them all at the same time.

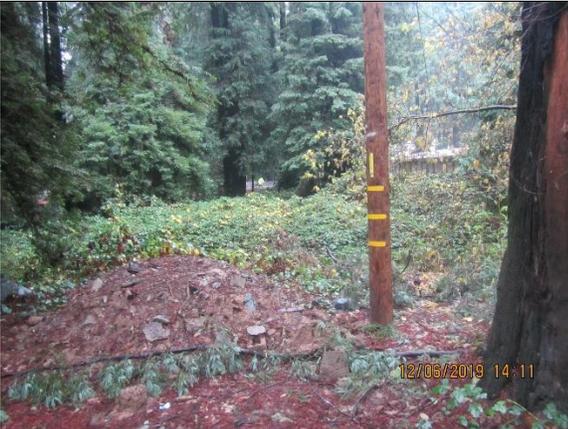
We next moved to Willow Road at approximately 1415 so we could view a mainline (MH 76-29 to MH 76-50) constructed beneath an existing drainage channel (**Photo 25**). This pipe was identified as a vulnerable area in RRCSD's Hazard Mitigation Program. The downstream manhole (MH 76-50) was located beside Willow Road and opened for the inspection team to observe. A dark silty material was observed on the bench (**Photo 26**). This mainline is located downstream from a restaurant, but no signs of grease were observed during the inspection.

**Photo 25:** Existing drainage channel adjacent to Willow Road. Mainline 76-29 to 76-50 runs beneath this channel.

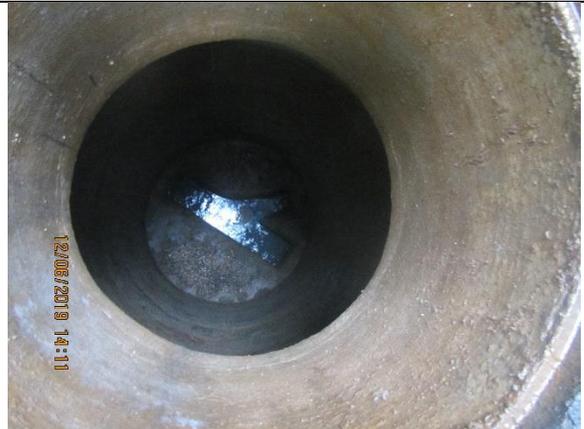
**Photo 26:** Inside of MH 76-50 located on Willow Road. Dark, silty material was observed on the bench. No signs of FOG at time of inspection.

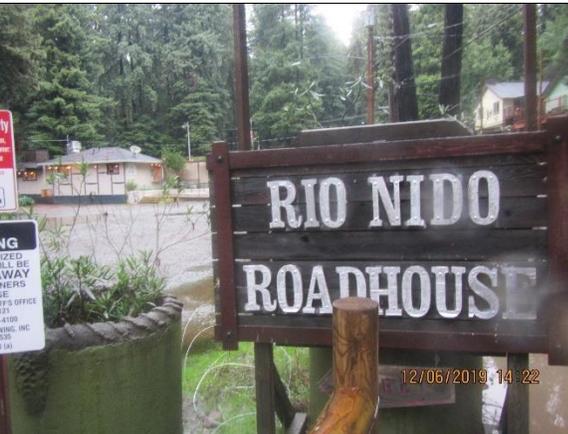
We next walked to Canyon 2 Road to view a mainline (MH 72-10 to MH 76-44) located downstream from the Rio Nido Roadhouse restaurant (**Photo 27**). Agency staff stated Rio Nido Roadhouse is one of their largest producers of FOG and has installed a grease interceptor to reduce FOG impacting the collection system. Agency staff opened both manholes for us to view. No evidence of grease was observed at the time of the inspection. However, both manholes had large amounts of a black silty material on the bench (**Photo 28**). Agency staff said this is likely silt from past flooding. In addition, the manhole downstream of Rio Nido Roadhouse had a white material coating the barrel. Agency staff said that this may be a bacterial growth.

**Photo 27:** Rio Nido Roadhouse restaurant, large producer of FOG. Grease interceptor has been installed at restaurant.

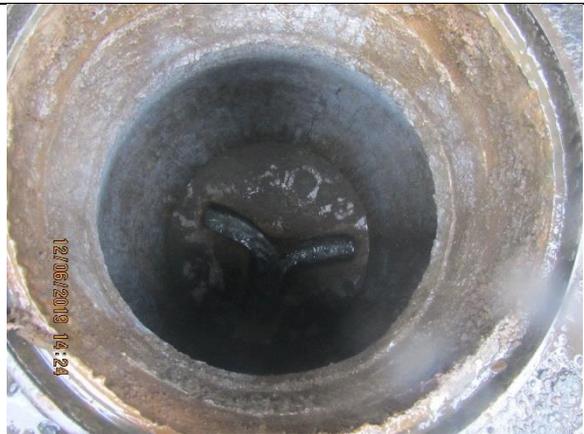
**Photo 28:** Manhole downstream of Rio Nido Roadhouse. Dark, silty material was observed on the bench. No signs of FOG at time of inspection.
